**AUGUSTA COUNTY SERVICE AUTHORITY
VERONA, VIRGINIA**

SEWER SERVICE ABANDONMENT

DRAWING NUMBER: S-12

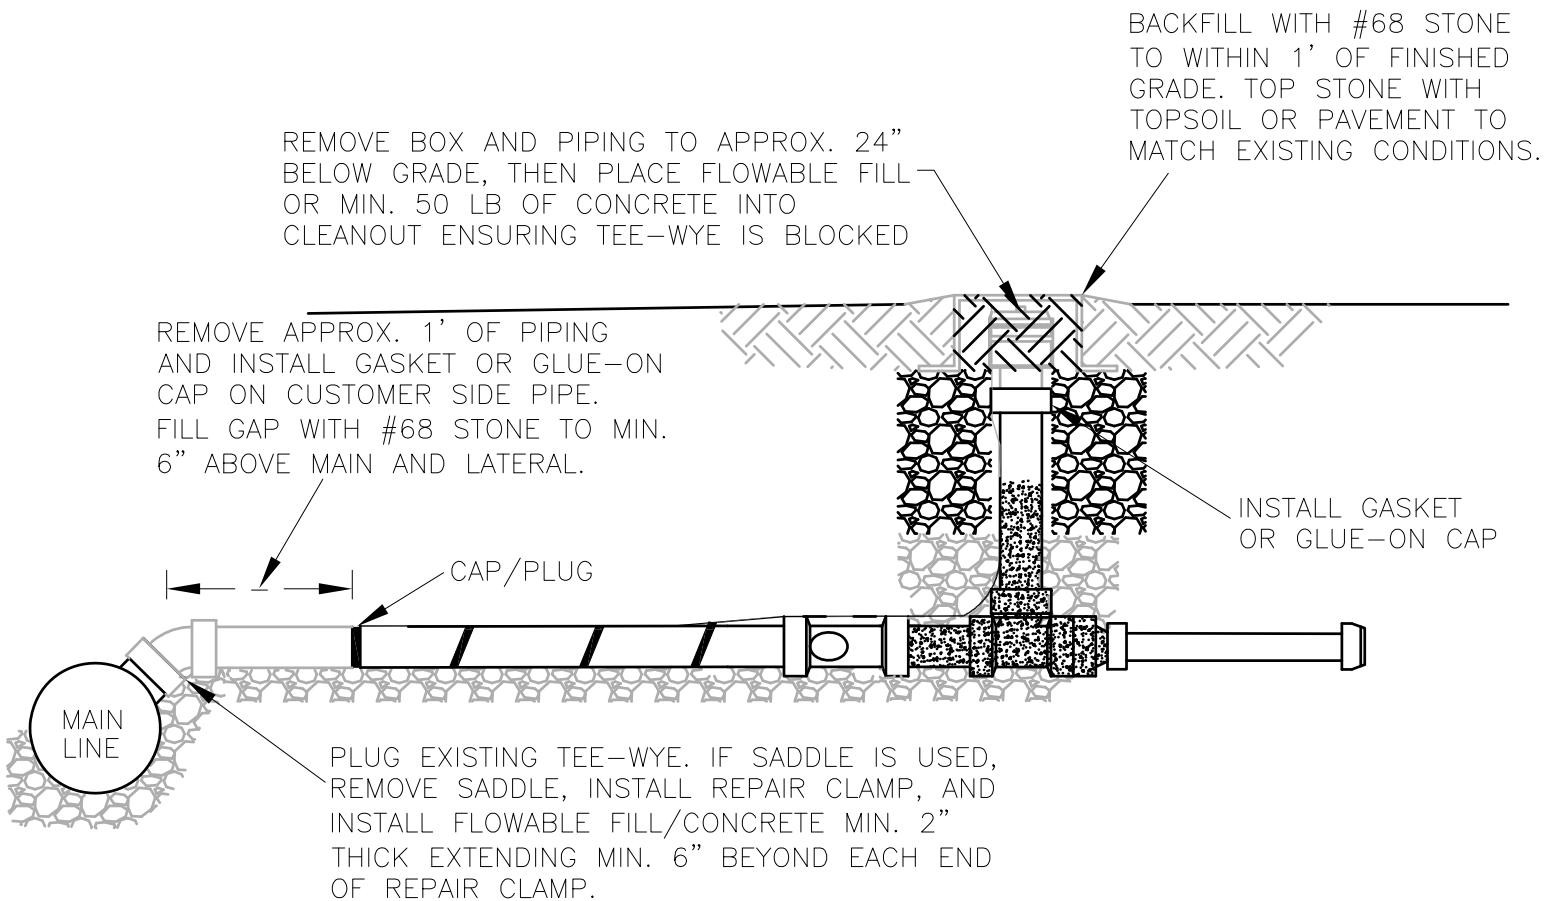
1. CLEANOUT FRAME AND COVER TO BE RETURNED TO THE ACSA.
2. ANY WORK TAKING PLACE ON ASBESTOS CEMENT PIPE IS TO BE PERFORMED BY CERTIFIED PERSONNEL.
3. SEE ACSA DETAIL S-10 FOR LATERALS ENTERING A MANHOLE.
